How does over two decades of active wood reintroduction result in changes to stream channel features and aquatic habitats of a forested river system?

George R. Pess¹

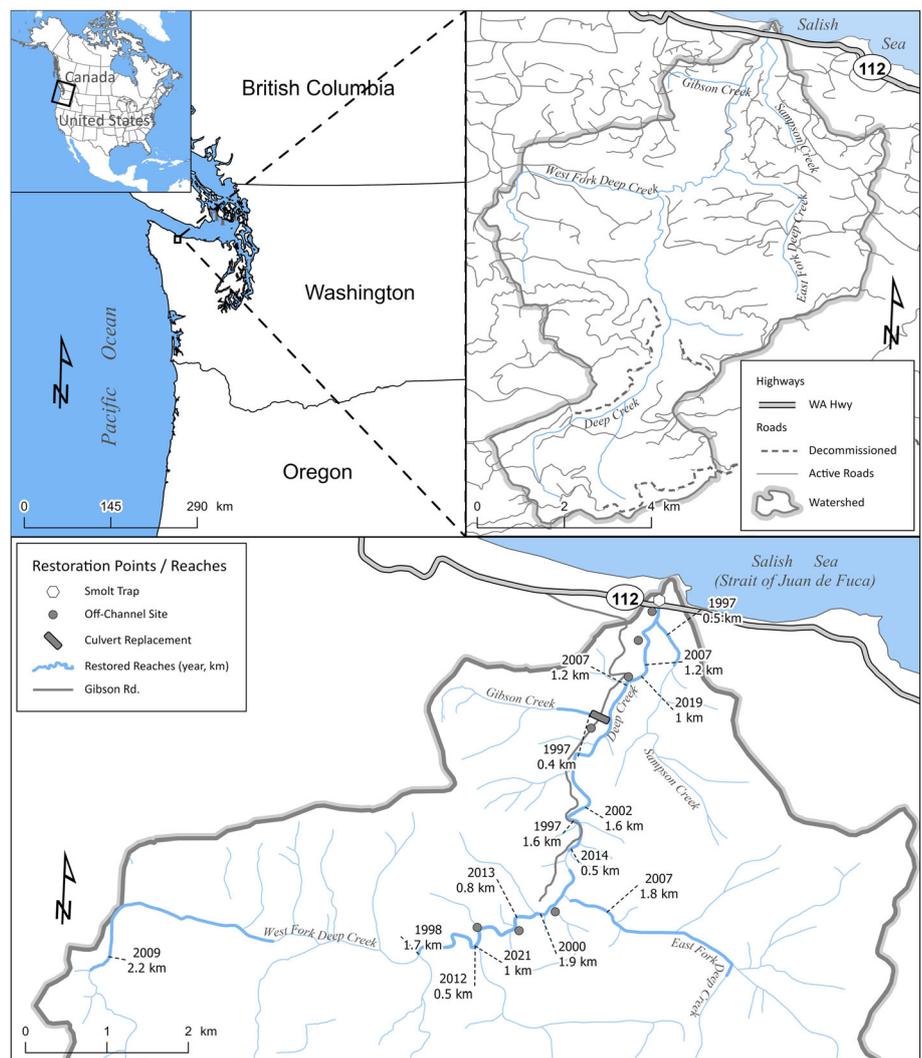
FIGURE 1 Deep Creek catchment and its location in Washington state, and the reach location and time period of wood addition treatments

The Deep Creek catchment covers an area of 45 km² in the northwest portion of the Olympic Peninsula, Washington State, USA (Figure 1). The geology of Deep Creek is characterized by Crescent Formation volcanic rock in the upper catchment, resulting in steep, confined stream channels (Snaveley et al., 1980; United States Forest Service et al., 2002). In contrast, glacial deposits, as well as marine sedimentary rocks, both of which are subject to intense erosion, dominate the middle and lower catchment (Snaveley et al., 1980; United States Forest Service et al., 2002).

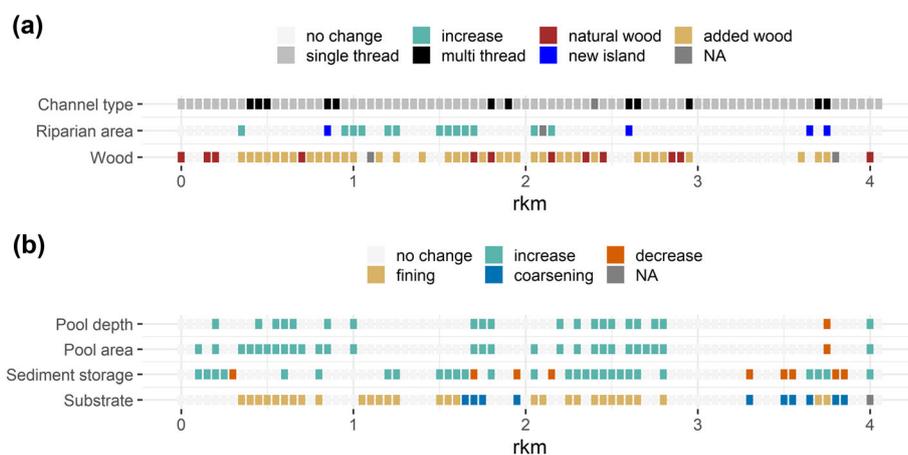
FIGURE 2 (a) Representation of the changes to reach-scale elements of Deep Creek from 1997 to 2020 using photo points from rkm 0.0 to 4.0. (b) Representation of the changes to in-channel elements of Deep Creek from 1997 to 2020 using photo points from rkm 0.0 to 4.0

We documented multiple qualitative stream channel changes in Deep Creek associated with wood additions between 1997 and 2020 (Figure 2a,b). Wood loadings were observed to have increased extensively in the lower 3.0 km (rkm 0.0 to 3.0) of Deep Creek (Figure 2a). There was also an increase in riparian vegetation in the lower 3.0 km. The number and size of riparian zone trees increased within the lower 2.0 km. New secondary channels were evident in several locations in 2020 (Figure 2a). Forested islands (four) also developed in specific areas of Deep Creek throughout the lower 4.0 km (Figure 2a). Both observed pool area and depth increased for many segments between rkm 2.0 and 3.0, often coupled with increased sediment storage and substrate fining (Figure 2b). Observed pool area increases and substrate fining also occurred in the lower 1.0 km of Deep Creek (Figure 2b).

A downstream transition in pool-forming factors from bedrock-dominated to logjam-dominated in the lower 3 km (Figure 8d), coincided with increased sediment storage and substrate fining, a decrease in stream power, and ultimately changes to stream channel type (Figure 2a,b). Sediment storage due to wood loadings can

Stream channel narrowing through vegetation recruitment was also evident through photo points and observation (Figure 2a). Narrowing occurred in the lower 3 km, where log frequency and snag frequency were highest (Figure 8a,c). Protection of riparian areas, in combination with increased frequencies of wood and debris jams, allows vegetation and wood to work together, which can lead to channel narrowing as well as greater heterogeneity in the longitudinal profile of a stream (Abbe & Montgomery, 2003; Mao et al., 2020; Montgomery & Abbe, 2006; Opperman & Merenlender, 2004).

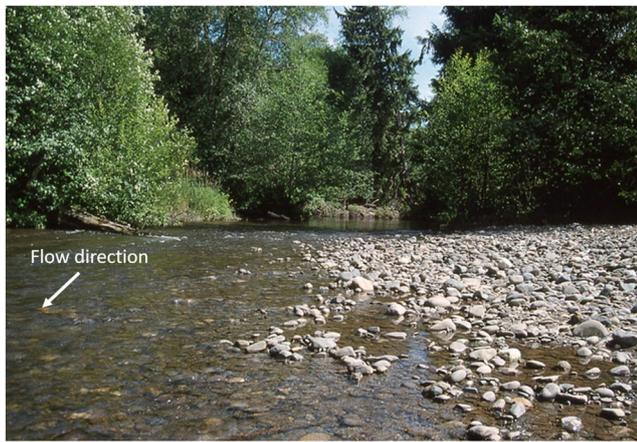
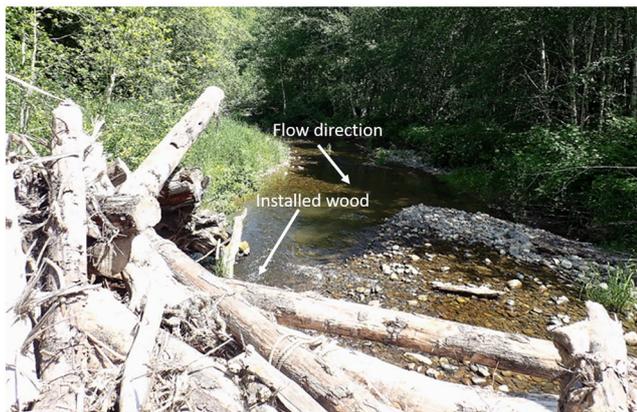
FIGURE 3 (a) Photo points of Deep Creek, rkm 0.0 to 1.0. Plane-bed channel in 1997. (b) Photo points of Deep Creek, rkm 0.0 to 1.0. Forced pool-riffle channel in 2020. Note increased wood and reduced substrate size in 2020

Figures 3–7 are examples of some of these changes. Between rkm 0.0 and 1.0 we observed that extensive wood accumulation resulted in a visual change from a plane-bed dominated reach to a forced pool–riffle sequence (Figure 3a,b). The creation of an anastomosing stream reach occurred where a mid-channel engineered logjam was created between rkm 0.3 and 0.5, and new channels formed (Figure 2a). Channel narrowing and vegetation recruitment on the stream banks and gravel bar areas also resulted from the change in wood accumulation (Figures 2a and 3b).

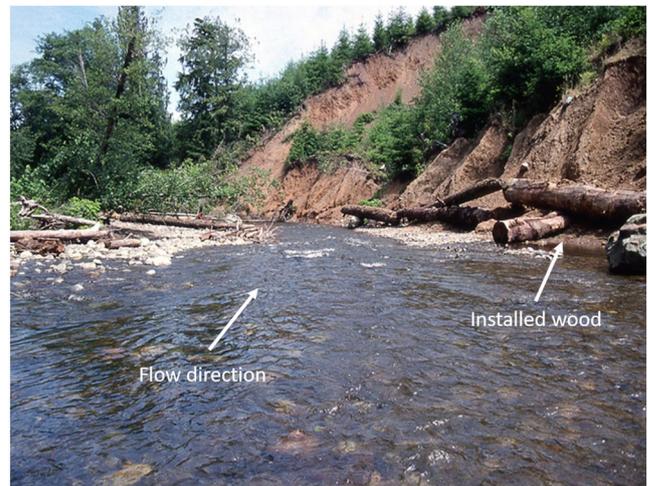
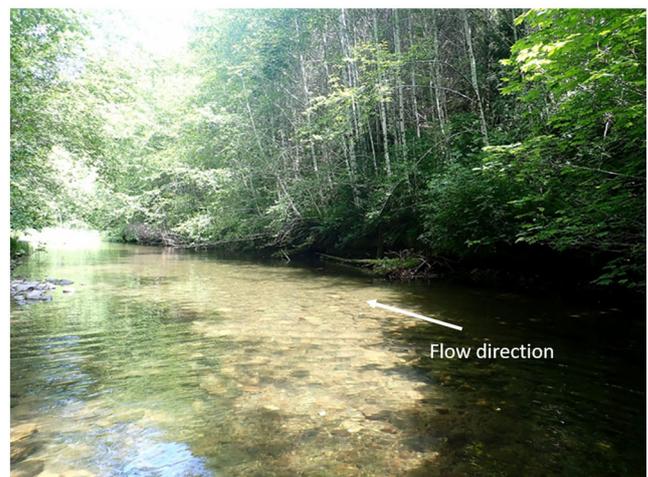
FIGURE 4 (a) Photo points of Deep Creek, rkm 1.0 to 2.0. Deep-seated landslide in 1997. (b) Photo points of Deep Creek, rkm 1.0 to 2.0. Deep-seated landslide revegetation and stabilization in 2020

For rkm 1.0 to 2.0 there were several significant changes associated with the increase in wood accumulations. A deep-seated landslide from rkm 1.5 to 1.6 revegetated due to the construction of a wood revetment along the toe of the failure on the east bank of Deep Creek (Figure 4a,b). The revetment allowed riparian vegetation, particularly red alder (*Alnus rubra*), to establish on the placed wood as well as the stabilized hillslope (Figure 4b). The wood pieces, combined with the stabilization of the landslide, resulted in a narrower active channel, riparian encroachment and a decrease in the observed width-to-depth ratio through the reach (Figures 2a and 4b). Secondary channels now occur in the majority of Deep Creek between rkm 1.5 and 2.0 (Figure 5a,b).

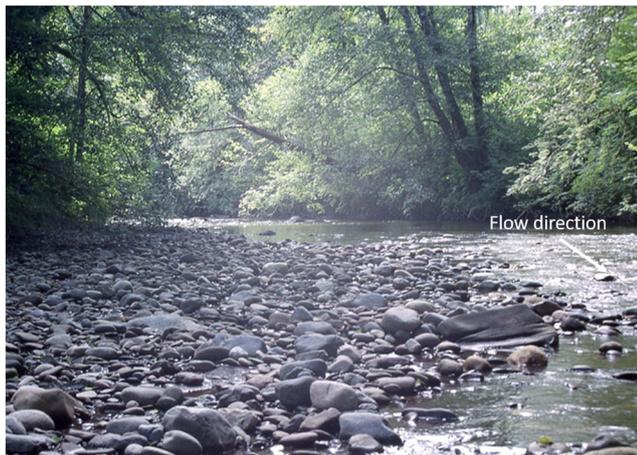
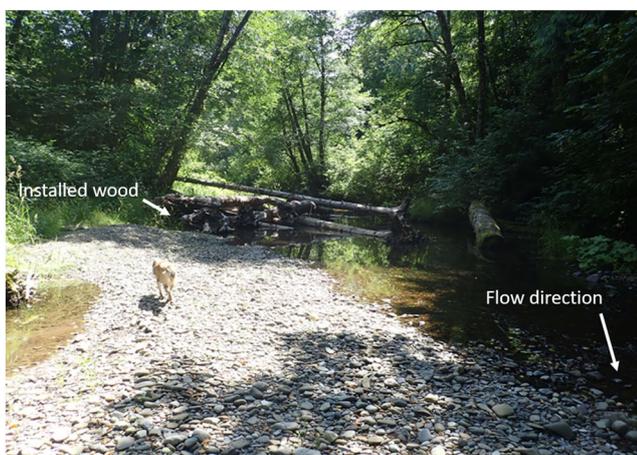
FIGURE 6 (a) Photo points of Deep Creek, rkm 2.0 to 3.0. Plane-bed channel in 1997 prior to wood placement. (b) Photo points of Deep Creek, rkm 2.0 to 3.0. Forced pool-riffle

Approximately 400 m of Deep Creek between rkm 2.0 and 3.0 was converted from a cobble-dominated substrate with a widened channel and a lack of pools to a reach with reduced streambed particle size, noticeable wood accumulations, and increased pool area (Figure 6a,b). Observed bar deposits are now gravel rather than cobble, and channel narrowing, along with vegetation encroachment, are common. Pools have become more frequent and larger in observed surface area. Wood accumulation areas include channel-spanning logjams at rkm 2.2, 2.7, and 2.8 (Figure 2a). Side channels also now exist at rkm 2.2, 2.4, 2.6, and 2.9 (Figure 2a).

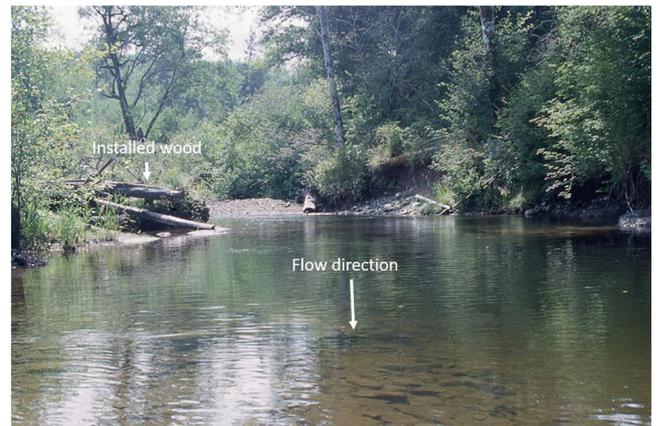
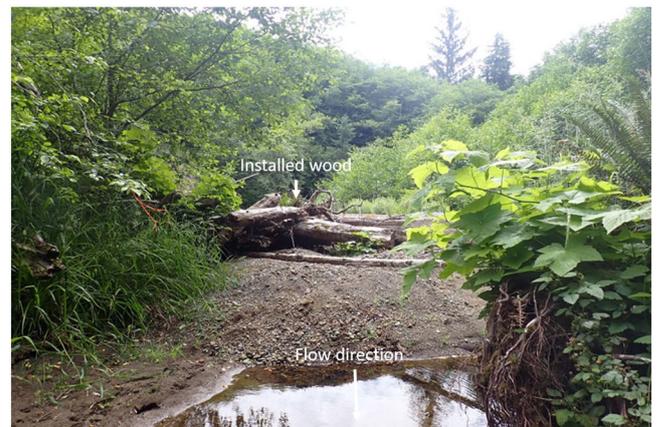
FIGURE 7 (a) Photo points of Deep Creek, rkm 3.0 to 4.0. Photo from 1997. Channel with wood and reduced streambed particle size in 2020. (b) Photo points of Deep Creek, rkm 3.0 to 4.0. Increased sediment storage and vegetation in 2020

The Deep Creek reach with the identified fewest observed changes was between rkm 3.0 and 4.0. This reach of Deep Creek was identified during restoration implementation as less suited to be treated with the addition of wood. Thus, with the exception of wood placement at rkm 3.7 to 3.9, where the valley begins to widen, there was not significant wood placement. The only changes observed in this reach are associated with an engineered logjam associated island at rkm 3.7, where a side channel and forested island have formed (Figure 2a,b). The area with the logjam has increased sediment storage, streambed fining, increased wood accumulation, and a decreased width-to-depth ratio (Figure 7a,b).

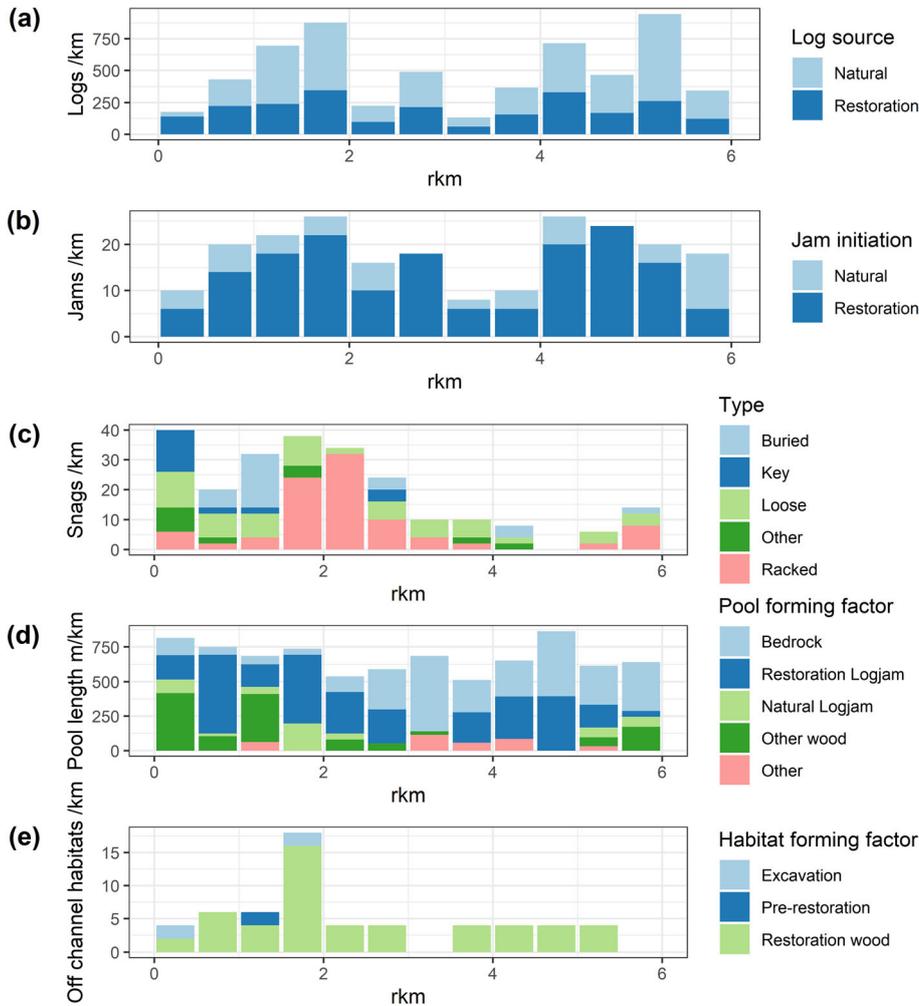
FIGURE 8 Deep Creek wood storage and associated stream characteristics. (a) Restored and natural logs/km. (b) Restored and natural logjams/km. (c) Snags number/km and associated type. (d) Pool length/km and associated pool-forming factor. (e) Floodplain channels/km and associated habitat-forming factor

We measured 2954 total logs, of which 1197 (~41%) were of restoration origin. Log distribution peaked at rkm 5.0, 4.0, 1.5, and 1.0 at ~500 logs/km or greater (Figure 8a). Over 75% of the current logjams are the result of restoration efforts (Figure 8b). However, those logjams have retained much of the natural wood that has fallen into Deep Creek and been mobilized downstream (Figure 8a). Logjams/km peak in several locations along Deep Creek, including rkm 5.0, 4.5, 4.0, 1.75, 1.5, and 1.0 at over 20 logjams/km (Figure 8b). In channel segments lacking logjams and associated stable key pieces, there is negligible wood.

The overall number of snags/km increases in the downstream direction, with the majority of snags identified as racked or loose pieces of wood on logjams (Figure 8c). Peak counts of snags over ~30/km occur at rkm 2.0, 1.75, 1.5, and 0.25 (Figure 8c). Key pieces are distributed in the lower 2.5 km of Deep Creek, with the vast majority in the lower 0.25 km (Figure 8c).

Pool length/km varied between a low of 500 m/km and a high of 875 m/km (Figure 8d). While variation in length was relatively minimal, pool-forming factors switched from being dominated by bedrock

in the upper 3 km to being dominated by restoration logjams in the lower 3 km (Figure 8d). Restoration logjams were also a major contributor to pool formation between rkm 4.0 and 5.5 (Figure 8d). Floodplain channels/km were consistently near 5/km throughout the extent of the study reach, with the exception of rkm 1.5, where the density of floodplain channels was over 15/km (Figure 8e). Over 90% of the floodplain channels in Deep Creek were formed by restoration wood (Figure 8e).

Observed changes in the stream channel characteristics of Deep Creek were, in part, due to long-term, continuous, and extensive wood additions. Before and after observations and photo points, and a post-restoration wood storage survey qualitatively and quantitatively aided to capture changes to the stream channel characteristics of Deep Creek due to wood additions. We hypothesize that wood additions aided in the observed changes in pool depth and pool frequency. Wood is critical in maintaining the pool quantity, frequency, and quality in forested settings (Montgomery et al., 1996). Pool length per kilometer in the lower 2 km of Deep Creek tended to be higher than in other reaches and was associated with higher densities of logs and snags (Figure 8b,c).

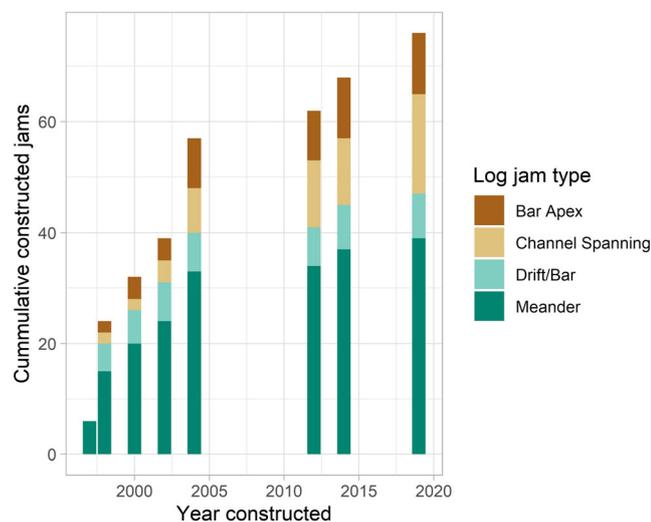
FIGURE 9 Deep Creek cumulative constructed logjams between 1998 and 2021

The number of constructed logjams increased over time in Deep Creek (Figure 9). The proportion of logjams that were

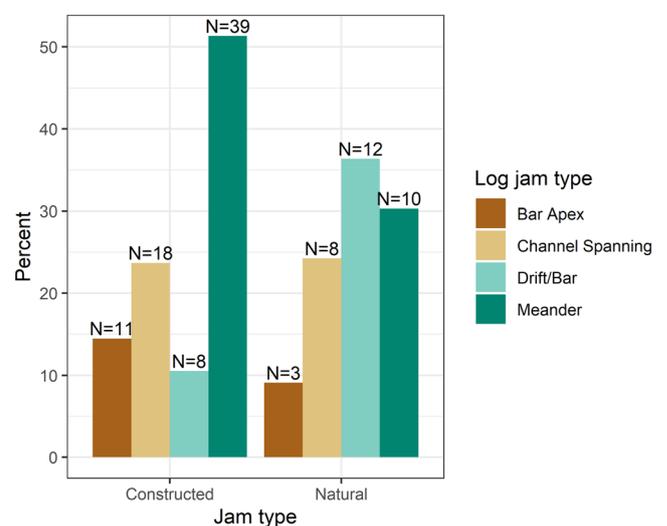
FIGURE 10 Deep Creek natural versus restored logjam type

identified as meander jams was the largest, followed by channel-spanning and bar apex jams (Figure 9). A comparison between constructed and natural logjams reveals a difference in the distribution of logjam type ($\chi^2 = 11.2$, $p = 0.05$) (Figure 10). Meander and channel-spanning jams make up 75% of all constructed jams in Deep Creek (Figure 10). Natural jams have a relative even distribution between channel-spanning, drift/bar, and meander jams. Channel-spanning jams constitute approximately 25% of the jam type, regardless of whether they are constructed or natural jams. Logjam type by location was dominated by meander jams, with the

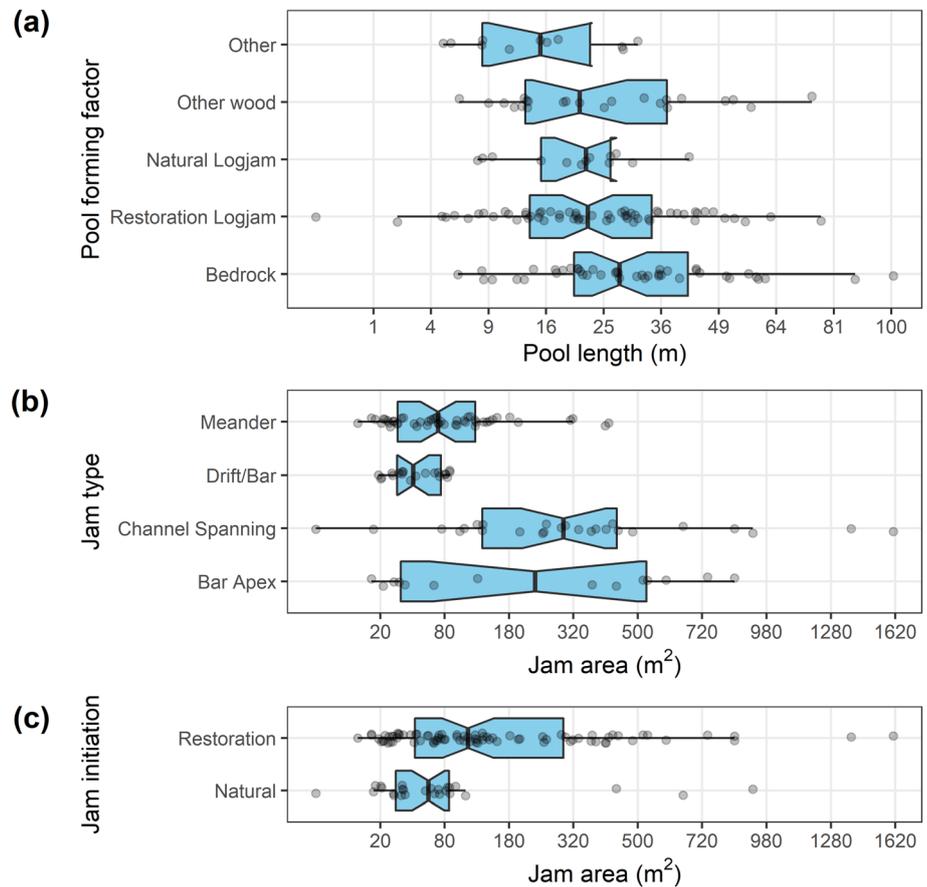
FIGURE 11 Individual pool and jam characteristics broken down by type. For all plots we used a box plot with the data points overlaid and jittered slightly horizontally for easier viewing. Non-overlapping notches indicate a statistically significant difference with an alpha of 5% (McGill et al., 1978). (a) Pool length by pool-forming factor. (b) Jam area by jam type. (c) Jam area by jam initiation type (restoration or natural)

Pool length varied by pool-forming factor (Figure 11a), with bedrock pools averaging the longest length, but all factors generating fairly similar pool lengths. Jam type was dominated by channel spanning and bar apex jams (Figure 11b). Restoration-initiated jams

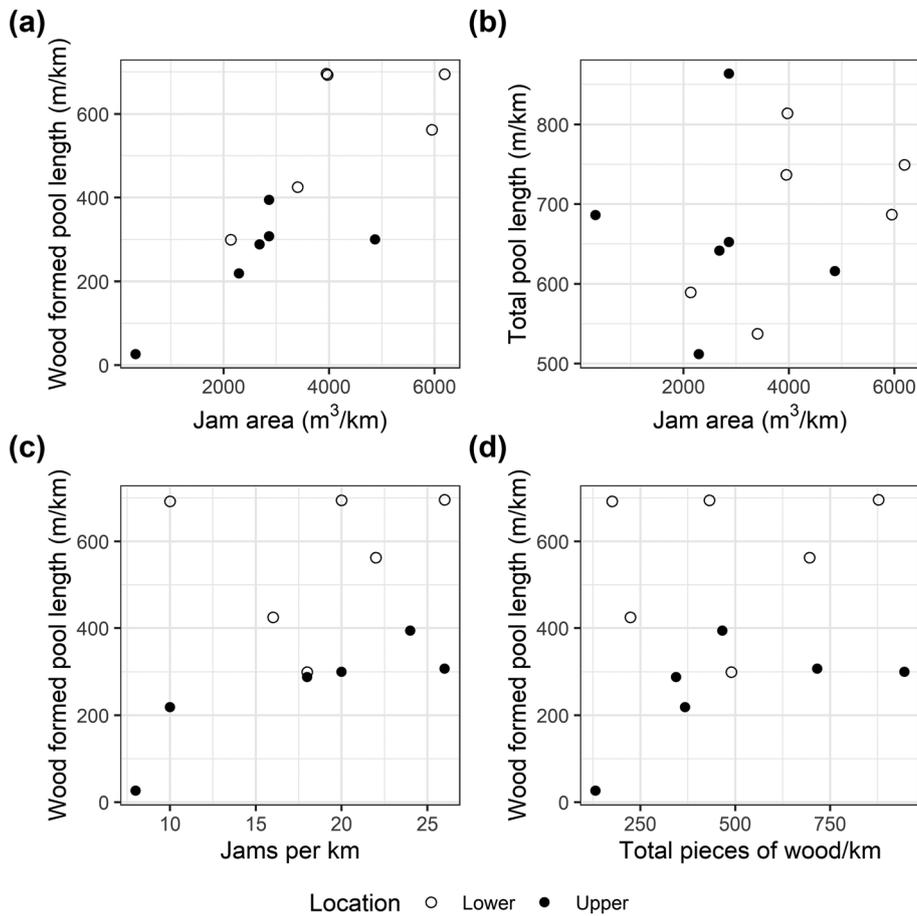
FIGURE 12 Relationship between reach-based summaries of pool area and logjam intensity. (a) Jam area versus pool area (formed by wood). (b) Jam area versus total pool area. (c) Jams versus pool area (formed by wood). (d) Total pieces of wood versus pool area (formed by wood). Point type indicates location in the basin (lower = rkm 0 to 3; upper = rkm 3 to 6)

created larger jam areas than natural jams (Figure 11c). Jam area correlated well with wood-formed pool length (Figure 12a), but not as well with total pool length (Figure 12b). Wood-formed pool length also increased with the number of jams per kilometer and total pieces of wood per kilometer in the lower portion of Deep Creek, but less so in the upper portion (Figure 12c,d).
